Technical Service Bulletin

| Technical Service Bulletin: TSB130055 | Released Date: 13-May-2013 |
| Heavy Duty Thermostat Stuck Open and/or Missing Flange Seal | |

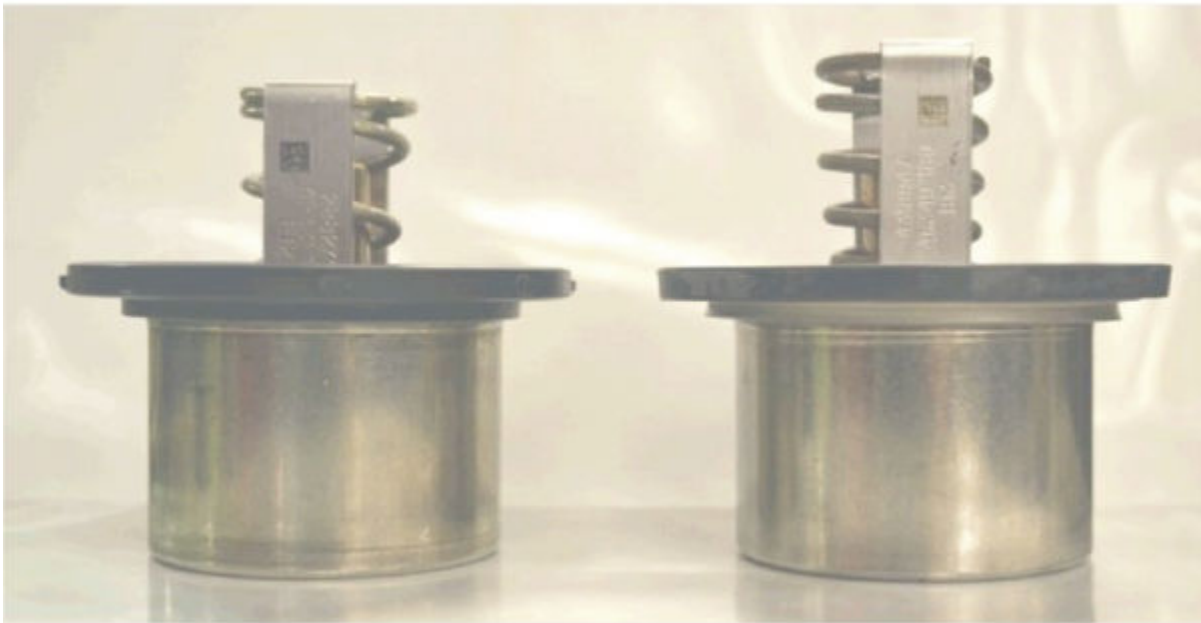
Figure 1: Old Thermostat, Part Number 4318197 vs New Thermostat, Part Number 4318947

Cases have been reported in which repair facilities have noticed the thermostat valve stuck open in the thermostat housing cover. When they remove the thermostat from the thermostat housing cover the thermostat closes and no longer appears to be stuck open. A thermostat in which the elastomer seal has failed will show a loss of elastomer material on the thermostat flange seal exposing the metal flange.

A new thermostat has been released to address both the stuck open and the flange seal failure modes that were reported. The new Cummins Part Number is 4318947, with the engine serial number (ESN) firsts from the plant in Table 1: ESN Firsts below. This new thermostat design has a higher force return spring which resulted in taller spring retaining arms. The flange seal of the thermostat has reverted back to a previous design using a 3-piece construction. This 3-piece flange consists of a metal flange, elastomeric seal, and steel retaining ring. Refer to Figure 1: Old Thermostat, Part Number 4318197 vs New Thermostat, Part Number 4318947, below for comparison of old and new thermostat.

Note : This new thermostat, Part Number 4318947, is **not** compatible with engines

assembled with dual thermostat housing options. The result of longer spring and spring retaining arms results in contact with the dual thermostat housing, preventing the thermostat from functioning properly. For engines using dual thermostat housing, use Part Number 4336659 for repairs.
