# Technical Bulletin

Bulletin No: TCH-023-007

## Subject: Potential Brake Pad Fitment Issue on Bendix® ADB22X® Air Disc Brakes

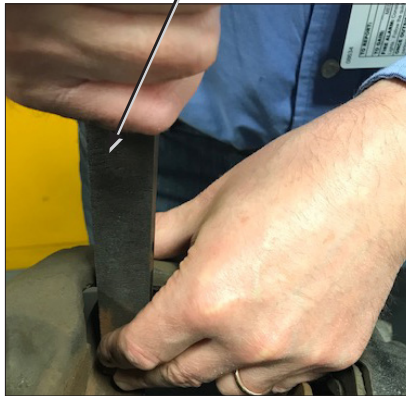
Filing the  
Abutment Surface

1. Assess the brake pad fitment within the brake carrier.
2. If the brake pads do not have adequate clearance, remove the pads and clean the abutment surface on the carrier with a flat file. **Do not use power tools.** Remove an even amount of material from the entire surface. Wipe clean. *See illustrations below.*

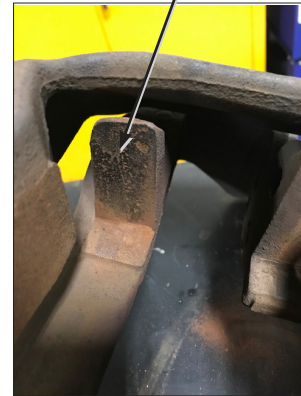
Abutment Surface  
Rust Removed

3. Insert the pads into the carrier and reassess the fitment.
4. If the pads do not slide freely into the carrier, repeat Steps 2 and 3. Note: Remove only the amount of material necessary to allow the pads to move freely.
5. If the pads still do not fit, swap the positions of the inboard and outboard pads.
6. Contact your Bendix representative or the Bendix Tech Team at 1-800-AIR-BRAKE (1-800-247-2725), option 2, for further assistance. Representatives are available Monday through Thursday 8:00 am - 6:00 pm and Friday 8:00 am - 5:00 pm. You can also reach the Tech Team by email at [techteam@bendix.com](mailto:techteam@bendix.com).
